# Sample Inspection Report

3939 Space Drive  
Houston TX 77000

## Sandstone Inspections

<b>Property Address</b> 3939 Space Drive Houston TX 77000	<b>Date of Inspection</b> 8/31/2023	<b>Report ID</b> 8-31-2023-samplerreport
<b>Customer(s)</b> Admiral Nelson	<b>Time of Inspection</b> 09:00 AM	<b>Real Estate Agent</b>

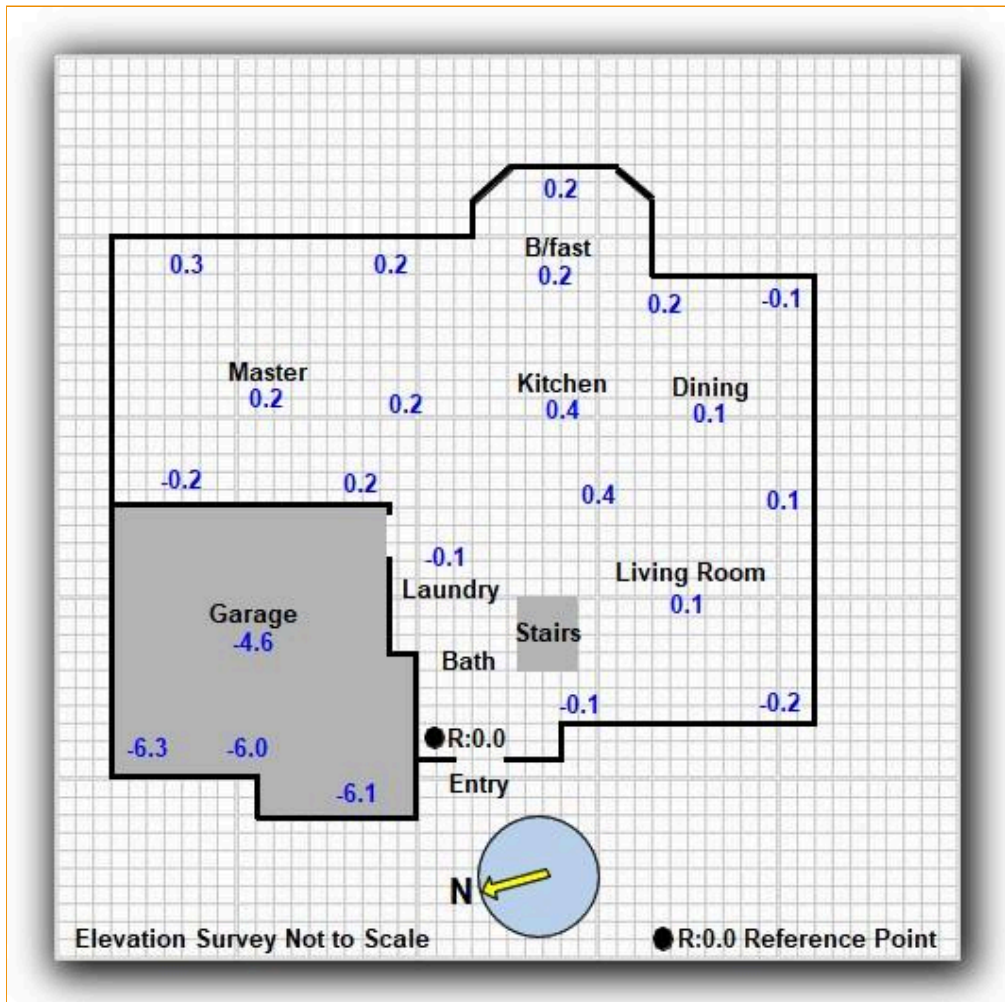
**FOUNDATION ELEVATION SURVEY:**

Foundation elevation measurements were taken during the inspection using a PRO 2000 Zip Level and adjusting for floor covering differences between different types of floor covering material. The reference point was located at the front door. The greatest variance from the point of reference was 0.4 inches (4/10s of an inch). This difference does not represent a major concern. No foundation repair is recommended at this time.

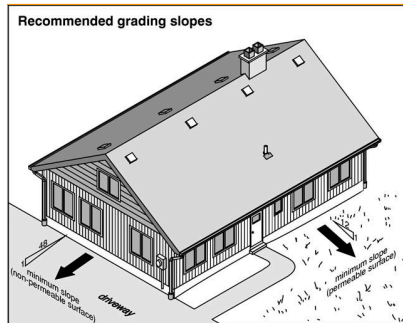
Soil grade and drainage patterns around some areas of the house do not appear to properly direct water away from the foundation to aid in controlling run off water. Water may pond/accumulate against the foundation. This condition may cause differential movement of the foundation and/or water penetration during heavy rains. Recommend filling in yard with soil to reach a grade slope away from the foundation of at least one inch per foot, and/or creating a drainage swale to help divert water away from the foundation.

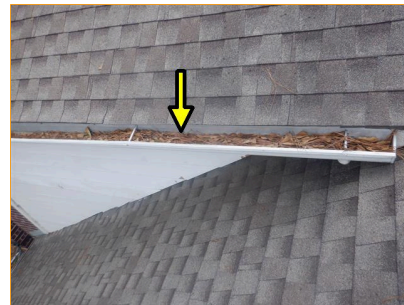
Gutters need general maintenance, Clean out debris and seal leaks.

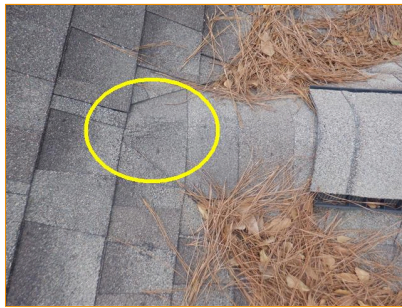
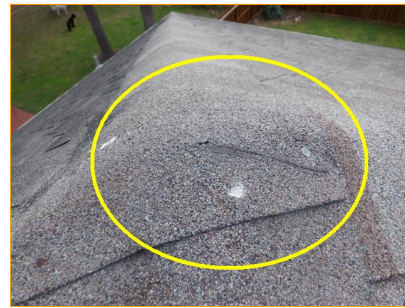
Scuffed / damaged shingles observed at one or more locations. Scuffing the mineral surface off of a composition shingle exposes the asphalt to ultraviolet light which causes it to deteriorate and can greatly reduce the life of the shingle. It is recommended to replace scuffed shingles.

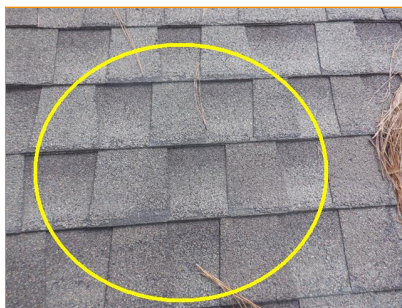
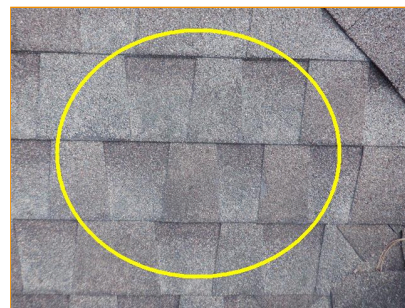
Granular loss shingles observed at various locations. The asphalt of the composition shingle is exposed to ultraviolet light; which causes it to deteriorate and can greatly reduce the life of the shingle.

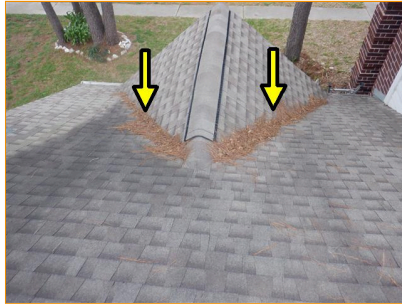
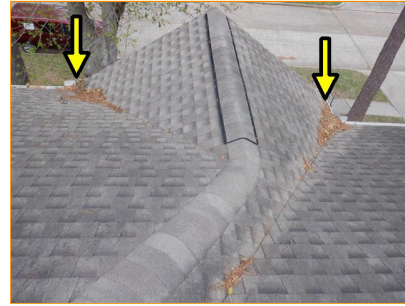
Debris observed on roof, which brings excessive moisture to the roof, can damage/ puncture the membrane and prevents visual inspection. It is recommended keep leaves from collecting on the roof, especially in valleys and keep tree limbs away from the roof to prevent damage to shingles and getting a roof clean up.

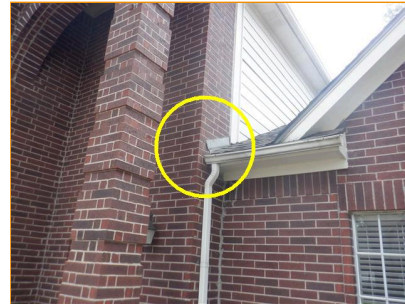
No "kick out" flashing observed where a roof terminates along a vertical wall. Kick out flashing is needed to encourage rain water running down roof to be diverted / "kicked out" away from vertical wall and reduce water running down vertical wall.

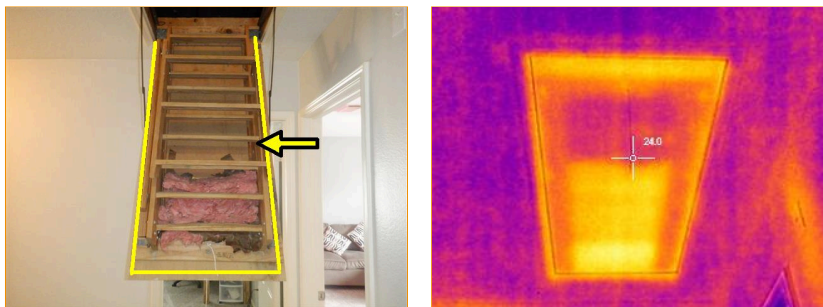
The attic access stairway is not sealed with weather stripping to prevent loss of conditioned air to the attic and/or sucking attic air into the house and/or is missing insulation on stairway. The infrared image to the right reveals area of energy loss. Recommend repair to save on energy bills.

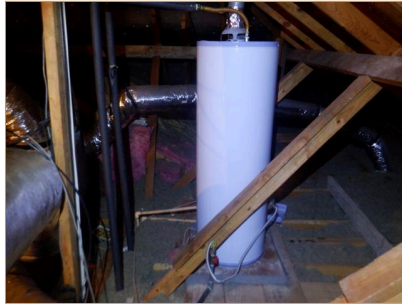
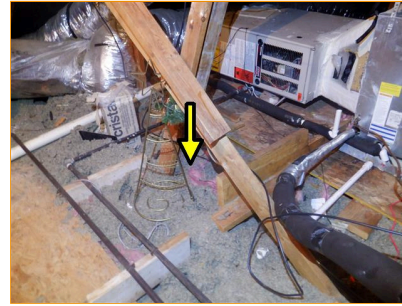
Inadequate passageway to water heater observed in the attic. Current standards require a minimum of 24 inches wide solid floor, and a maximum of 20 feet long.

Floor decking in attic is inadequate for service personnel servicing the HVAC system. Current standards require a minimum of 30 inch deep platform in front of unit.

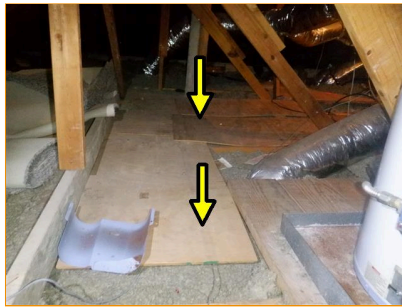
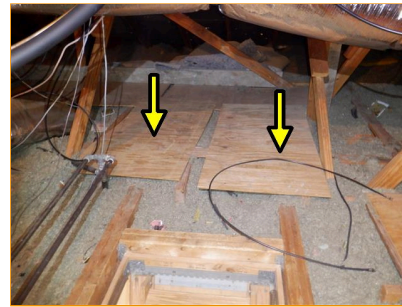
Observed loose attic boards/boards not properly nailed down may cause accidental tripping of service personnel and probable ceiling sheetrock damage.

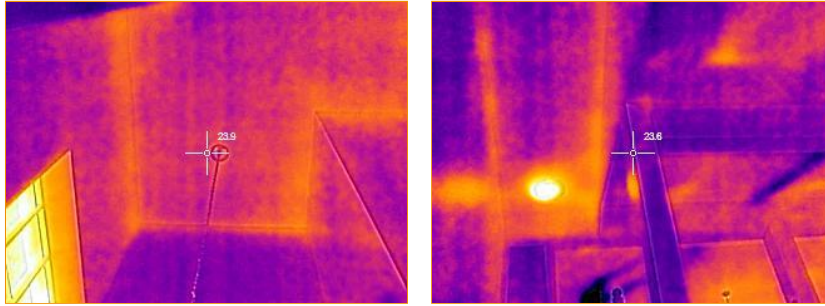
An infrared scan did not show areas of excessive moisture or areas of significant energy loss at the time of the inspection.

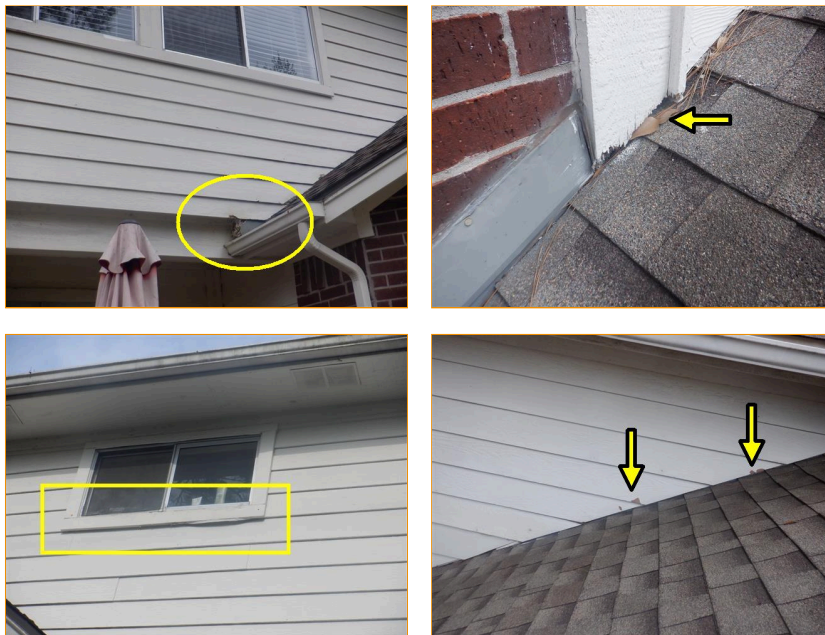
Damage/deterioration observed on exterior siding at various locations including around window frames; recommend repair/maintenance to prevent water penetration.

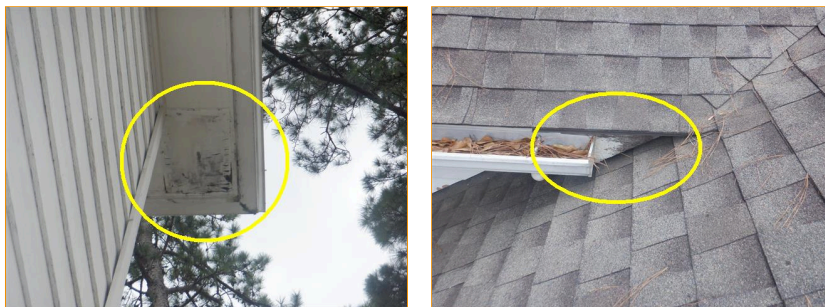
Wood damage observed around exterior fascia and/or soffit at one or more locations.

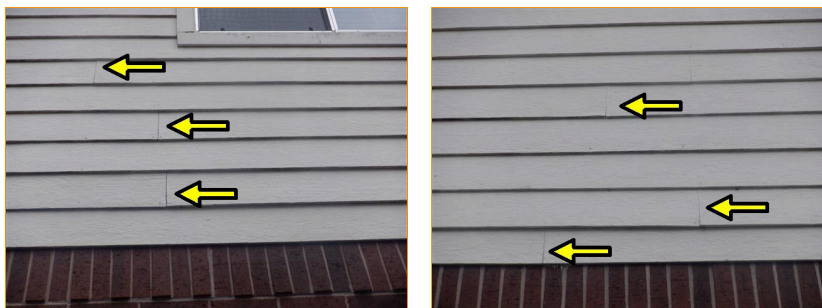
Sealing/caulking missing and/or deficient at vertical joints in siding; causes siding damage and may allow wind driven rain entry. The inspector can not determine the condition of wood

structural members behind the wall covered by building materials.

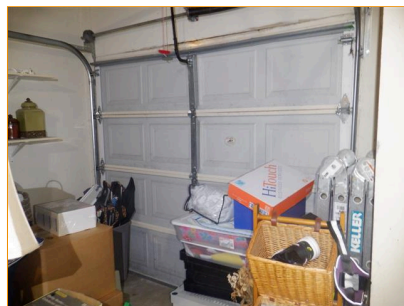
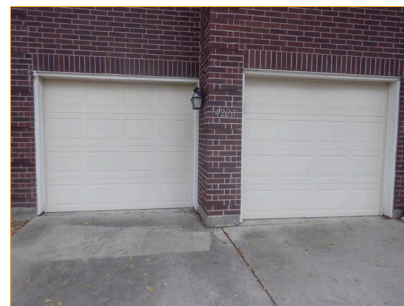
No interior mechanical lock observed in right side garage door. The garage door should have a mechanical lock to manually secure the door when there is no garage door opener installed, the opener is damaged, or there is no power to the house.

No handle observed in garage doors. The garage doors should have a handle to manually operate the doors when the garage door opener is damaged, or there is no power to the house.

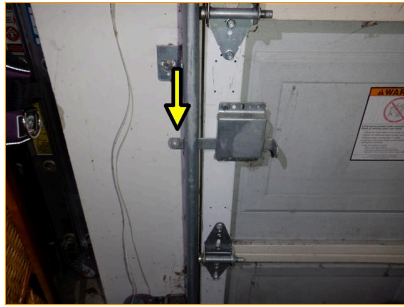
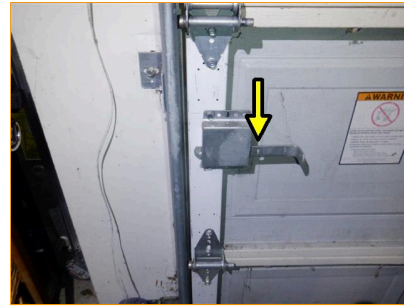
Garage doors equipped with openers should have door locks rendered inoperable to prevent

accidental damage to the door.

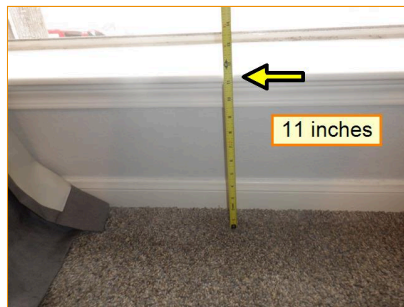
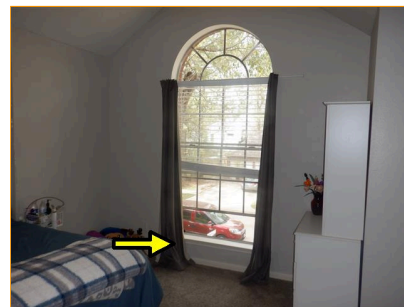
Potential fall hazard observed at second floor windows at front of the house. Operable windows located more than 72 inches above finished grade or surface below shall have sills a minimum of 24 inches above the finished floor of the room in which the window is located. Glazing between the floor and 24 inches shall be fixed or have openings through which a 4 inch diameter sphere cannot pass (CODE IRC R613.2).

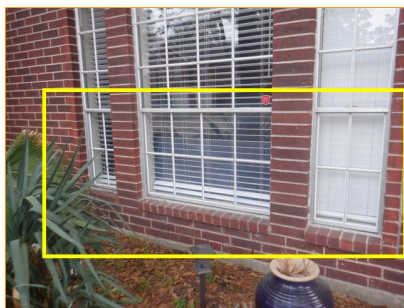
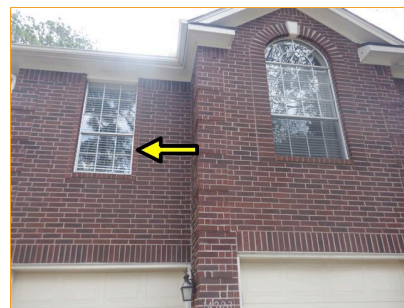
Observed various window screens around the house are missing and/or damaged.

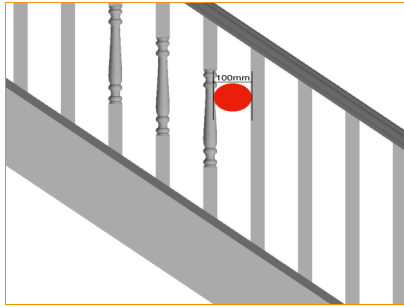
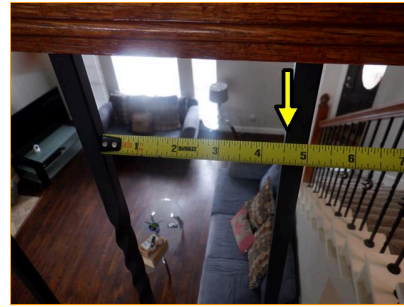
Space between railings does not comply with current industry standard, (code) UBC 421.1.1 & CABO D105.2.1. Requires spacing between intermediate rails do not allow passage of an object four inches in diameter. Recommend covering large openings in stair rails with

temporary type nylon netting if small children are present in house to prevent injury.

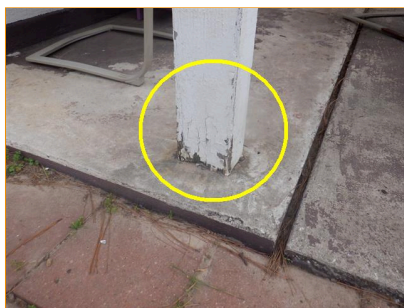
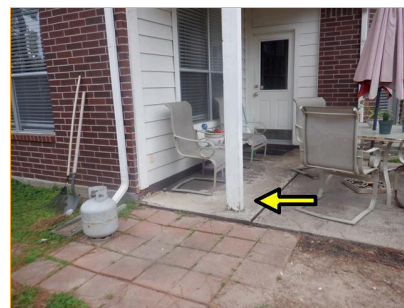
Wood damage/deterioration observed at bottom/base of backyard patio wood column.

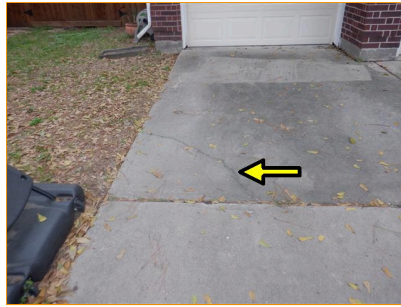
Cracks in walkways or the driveway observed. This type of cracks are typical and not related

to foundation movement.

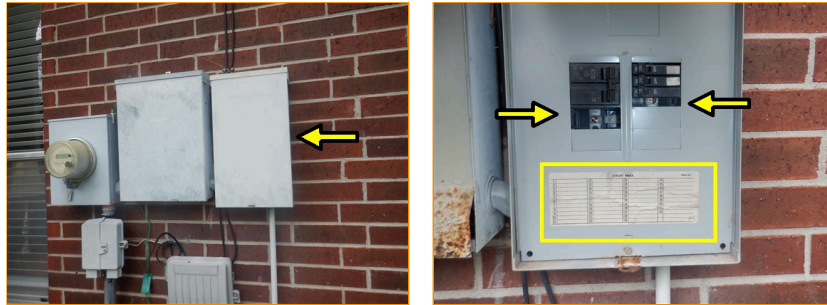
The electrical sub-panel is missing one or more bushings/knock out cover(s).

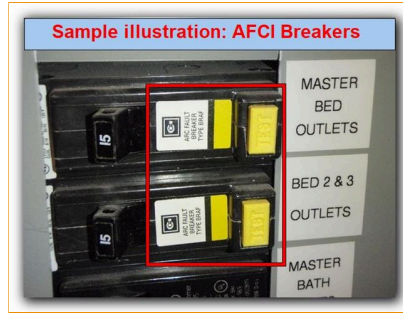
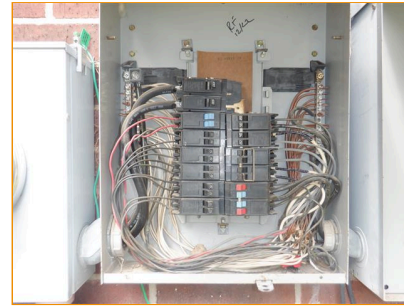
Observed no Arc Fault Circuit Interrupter (AFCI) device protection for all 15 and 20 amp receptacle outlets at family rooms, dinning rooms, living rooms, dens, bedrooms, sun rooms, recreation rooms, closets, hallways, or similar rooms around the house. AFCI devices are intended to protect against fires caused by electrical arcing faults in the house wiring. Current TREC Standards of Practice requires inspectors to indicate that a hazardous or

deficient condition exists regardless of the time the house was constructed.

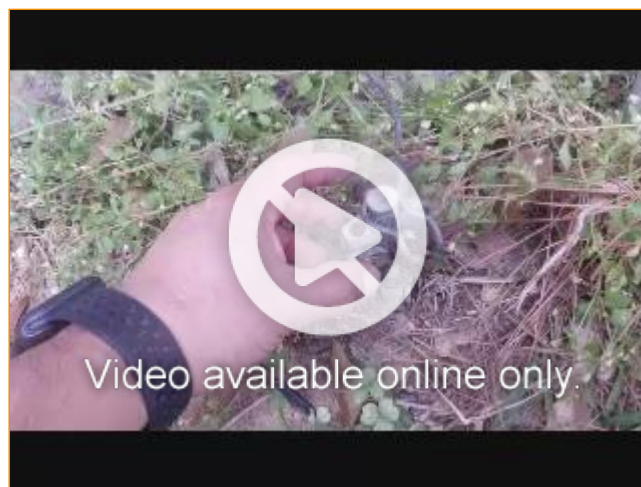
**The ground wire/wire clamp is loose from the ground rod; this condition represents a safety hazard; recommend repair.**

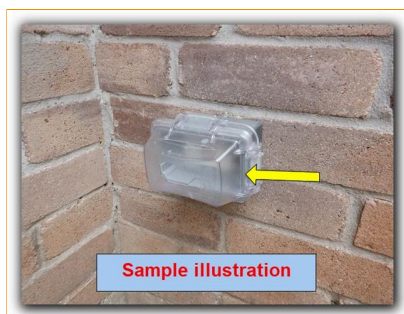
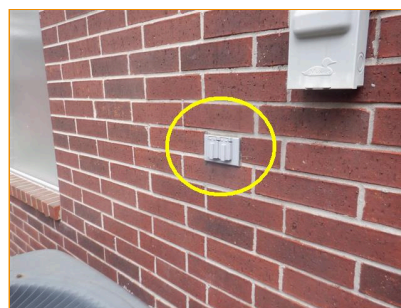
Observed one or more exterior outlets missing a weather proof cover. All exterior outlets whether in use or not are required to have in use weather proof cover per September 1st 2014 NEC Code Change. This condition represents a fire hazard. Recommend installing rain proof cover plates on all exterior outlets.

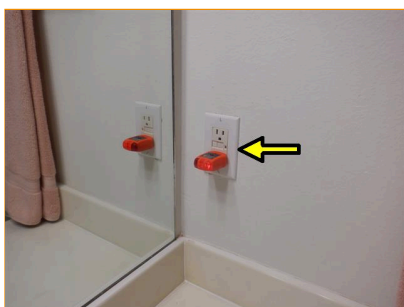
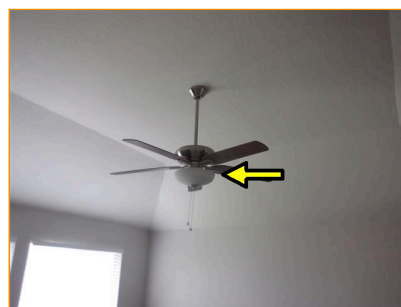
**No GFCI protection observed in the garage and the laundry room.**

**Insufficient GFCI protection observed in the kitchen.**

Observed all exterior outlets, bathroom outlets, and second floor den outlets and light fixtures are protected by a single GFCI outlet located in the second floor bathroom, which does not comply with current electrical standards. Recommend further evaluation and repair by a licensed electrician

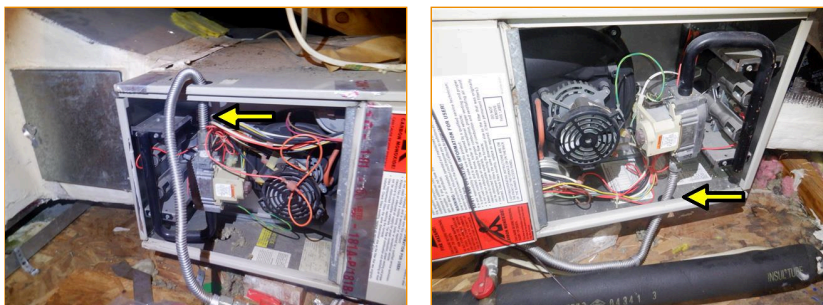
Observed flexible gas line passing through furnace metal cabinet at both heating units. Flexible gas line is not allowed by current industry standards and most installation instructions to pass into metal cabinet of gas heating units due to vibration from unit can rub hole in gas line, rigid metal pipe should extend outside cabinet a minimum of 2 inches for flex line connection.

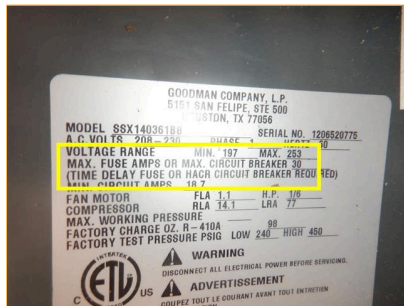
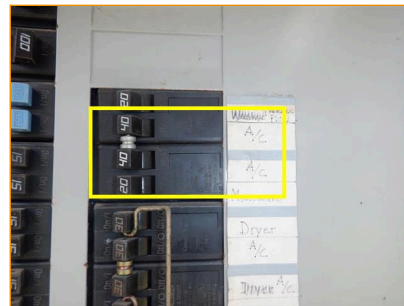
Observed improper sizing of breaker to condensing unit 2 may void manufacturer's warranty. Data plate on unit states maximum breaker size to be 30 amps, observed size in service panel is 40 amps.

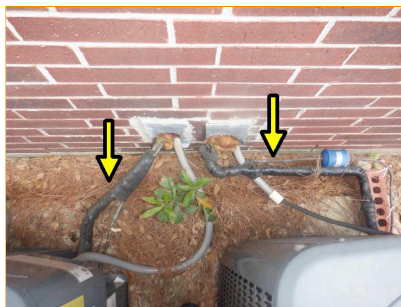
Observed suction line insulation is old, burned, and cracked at condensing units.

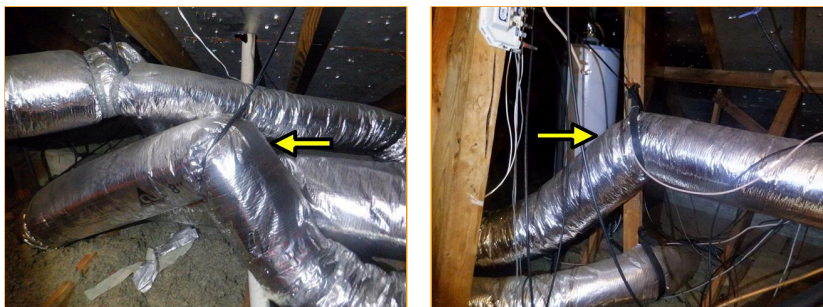
Improper sharp bends observed at one or more flex ducts in the attic. Improper routing increases frictional loss in the duct and reduces heating and cooling efficiency. Radius at centerline of the bend should be no less than the diameter of the duct.

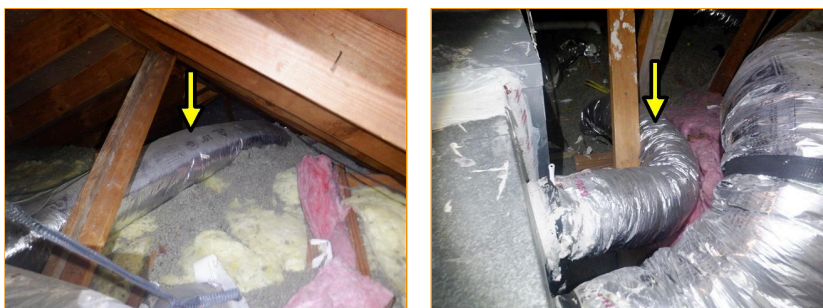
Observed air duct not properly supported with 1 and 1/2 inch nylon to prevent cutting or restricting flex duct as required by manufacture of duct. Ducts laying on the attic decking or insulation are prone to damage and leakage from condensation.

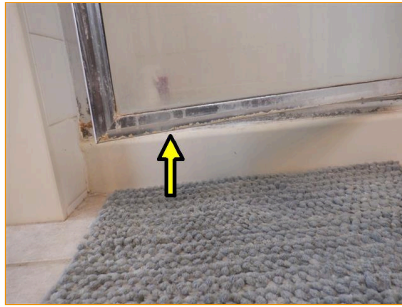
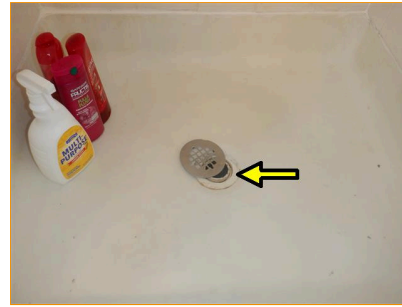
drain cover grill is loose.

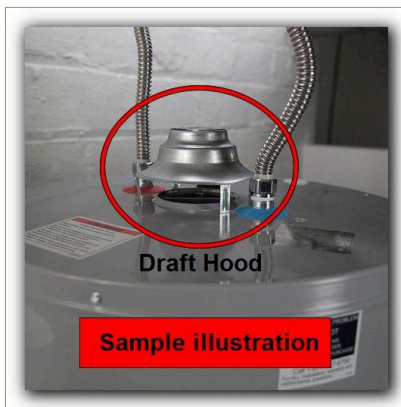
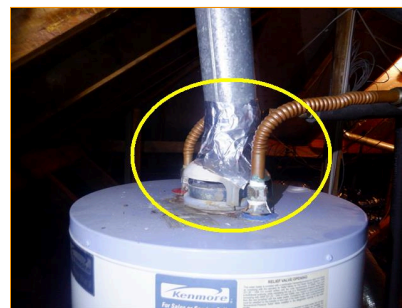
Observed water heater exhaust vent is not properly connected to the vent hood. Combustion gasses spill in the attic. Recommend repair.

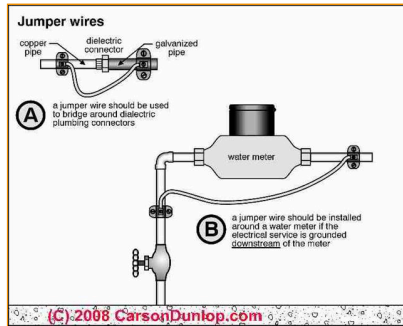
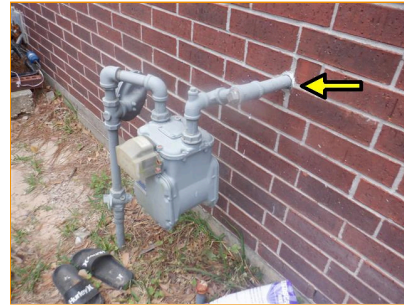
proper bonding of gas lines CSST (corrugated stainless steel tubing). Current standards require CSST to be bonded to minimize the risk of damage to the building materials from a nearby lightning strike.

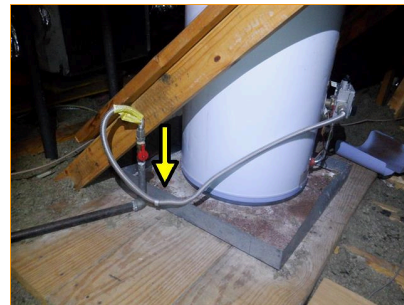
No drip leg observed on house heater and/or gas water heater. A drip leg is called for in the manufactures installation instructions.

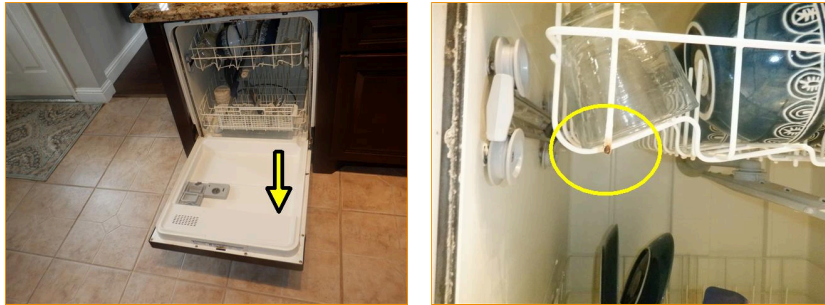
The dishwasher door opens past level. The door hinges are broken or the door springs are worn out. Minor rusting was observed at the dish racks.

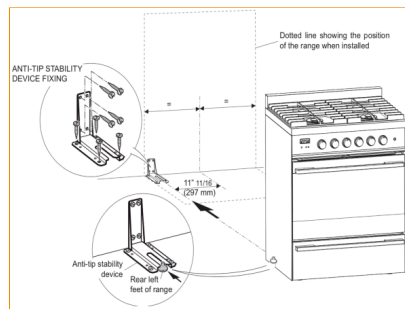
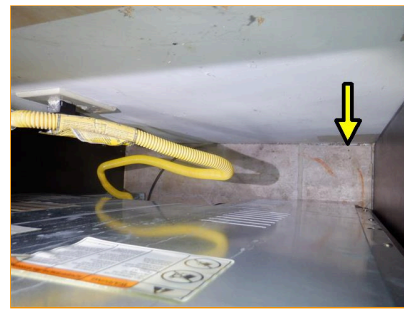
Observed cooking range is missing an anti-tip device, which is recommended as a safety measure to prevent the the appliance from tipping over when being used.

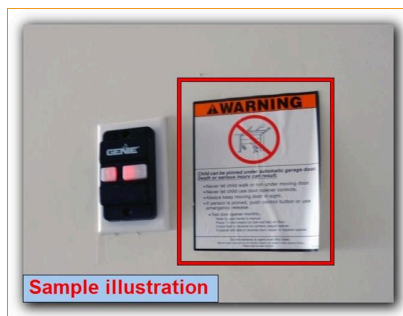
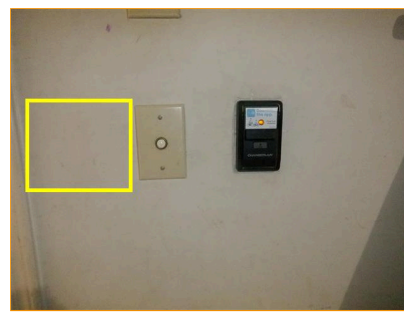
The equipped safety sticker / decal next to operator button is missing.
