# Sample Inspection Report

3939 Space Drive  
Houston TX 77000

## Sandstone Inspections

<b>Property Address</b> 3939 Space Drive Houston TX 77000	<b>Date of Inspection</b> 8/31/2023	<b>Report ID</b> 8-31-2023-samplerreport
<b>Customer(s)</b> Admiral Nelson	<b>Time of Inspection</b> 09:00 AM	<b>Real Estate Agent</b>

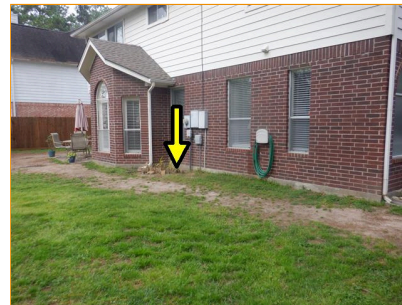
Soil grade and drainage patterns around some areas of the house do not appear to properly direct water away from the foundation to aid in controlling run off water. Water may pond/accumulate against the foundation. This condition may cause differential movement of the foundation and/or water penetration during heavy rains. Recommend filling in yard with soil to reach a grade slope away from the foundation of at least one inch per foot, and/or creating a drainage swale to help divert water away from the foundation.

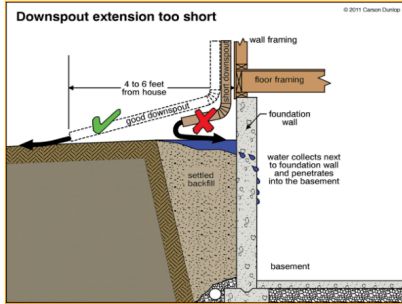
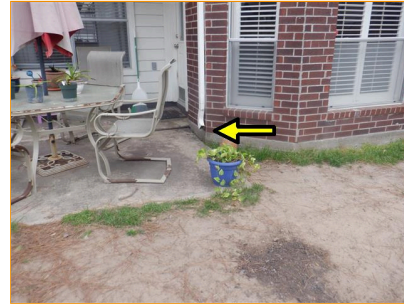
Rain gutter downspouts need to be redirected to drain water at least 36 inches away from the foundation and minimize possible wood rot, water entry, and/or foundation distress at various locations. Recommend extending downspouts to within 4 inches of the soil, installing downspout elbows, and installing splashblocks.

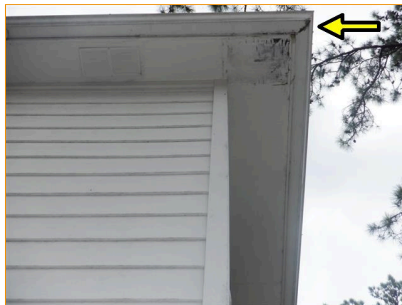
Gutters need general maintenance, Clean out debris and seal leaks.

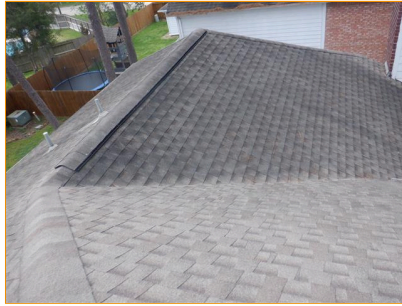
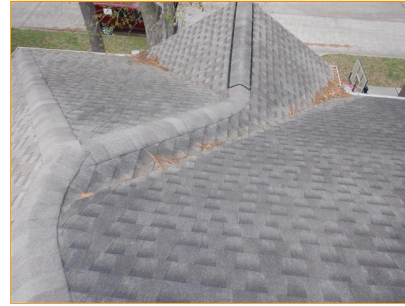
Scuffed / damaged shingles observed at one or more locations. Scuffing the mineral surface off of a composition shingle exposes the asphalt to ultraviolet light which causes it to deteriorate and can greatly reduce the life of the shingle. It is recommended to replace scuffed shingles.

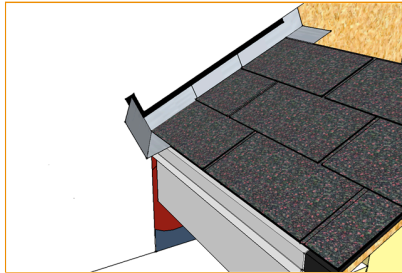
No "kick out" flashing observed where a roof terminates along a vertical wall. Kick out flashing is needed to encourage rain water running down roof to be diverted / "kicked out" away from vertical wall and reduce water running down vertical wall.

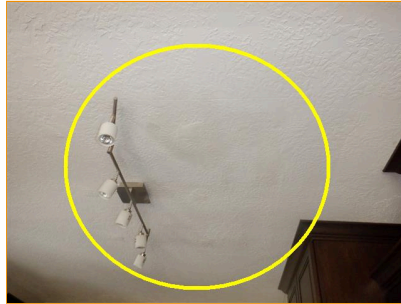
Evidence of previous repairs to the ceiling observed in the kitchen area. No excessive moisture observed at the time of the inspection

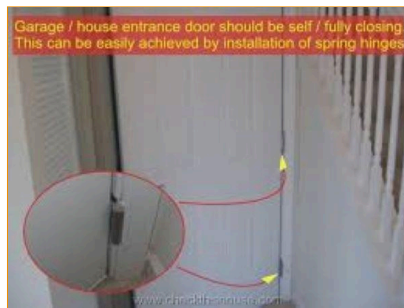
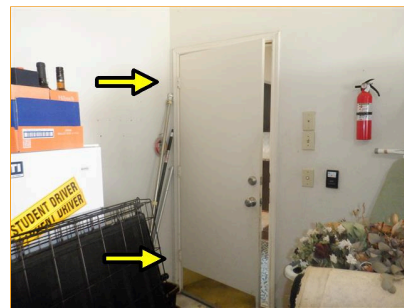
The door between the house and the garage does not have operational auto / self closing device as required by code, reference UBC 302.4 ex.3. Recommend installing a self closing device or self closing hinges to prevent car fumes from entering the living space.

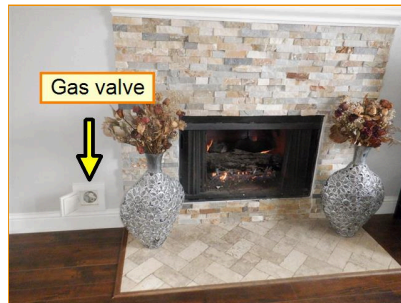
The fireplace was tested during the inspection and appeared to be functioning as intended

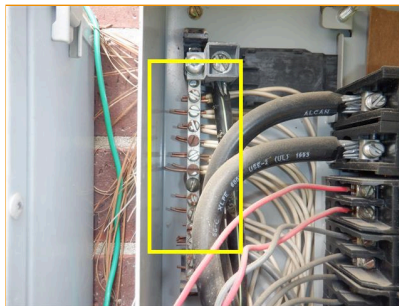
Observed two or more neutral conductors under one screw lug on the neutral bus. Current industry standards and National Electric Code permit one neutral conductor per screw lug.

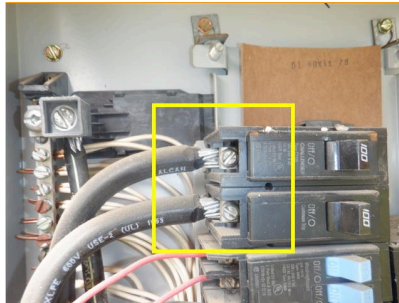
No anti-oxidant compound (grease) observed on the exposed aluminum feeder wiring and no insulated barrier observed at service entrance conductors. By current code (NEC 230.62C), any un-insulated, un-grounded conductor terminal or bus bar in the service disconnect must have a barrier covering it to protect service personnel.

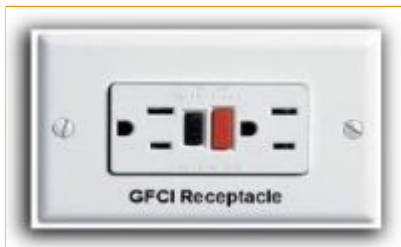
**No GFCI protection observed in the garage and the laundry room.**

**Insufficient GFCI protection observed in the kitchen.**

Observed all exterior outlets, bathroom outlets, and second floor den outlets and light fixtures are protected by a single GFCI outlet located in the second floor bathroom, which does not comply with current electrical standards. Recommend further evaluation and repair by a licensed electrician

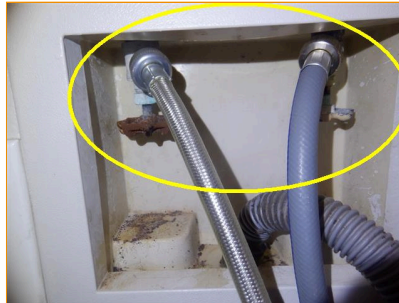
Rust observed at washing machine water supply valves in the laundry room.

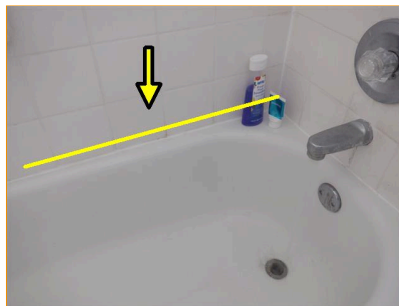
Observed grout / caulking needed in second floor bathroom tub at vertical tile corners, between tiles, and where tile meets tub to prevent water entry behind wall. One or more wall tiles are loose.

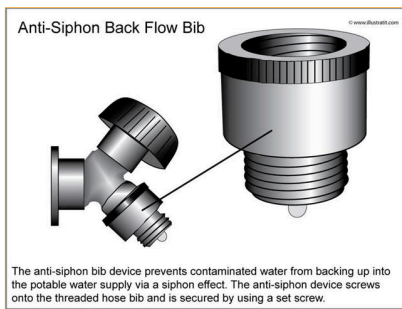
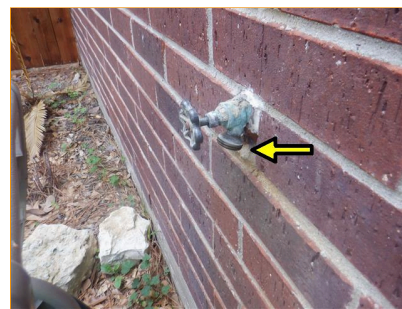
Exterior hose spigot(s) do not have code approved anti-back flow devices installed.

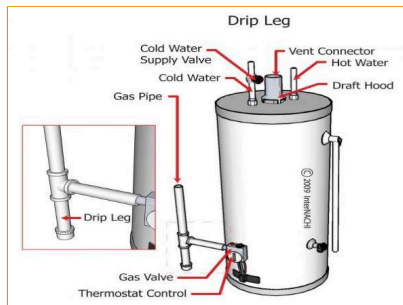
No drip leg observed on house heater and/or gas water heater. A drip leg is called for in the manufactures installation instructions.

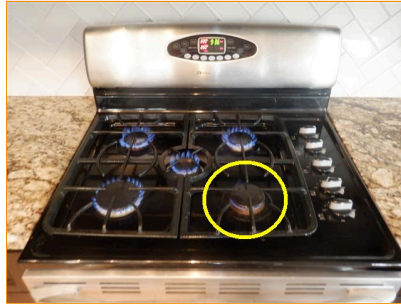
Observed cooking range is missing an anti-tip device, which is recommended as a safety measure to prevent the the appliance from tipping over when being used.
